# TECHNICAL MEMORANDUM

**Date:** February 15, 2024  
**To:** Honorable City Council, Marine on St. Croix  
**From:** Jacob Humburg, PE  
Daniel Foster, EIT  
**Subject:** Drainfield Treatment System Evaluation  
Marine on St. Croix, Minnesota  
Technical Memorandum  
Project No.: ON1.133074

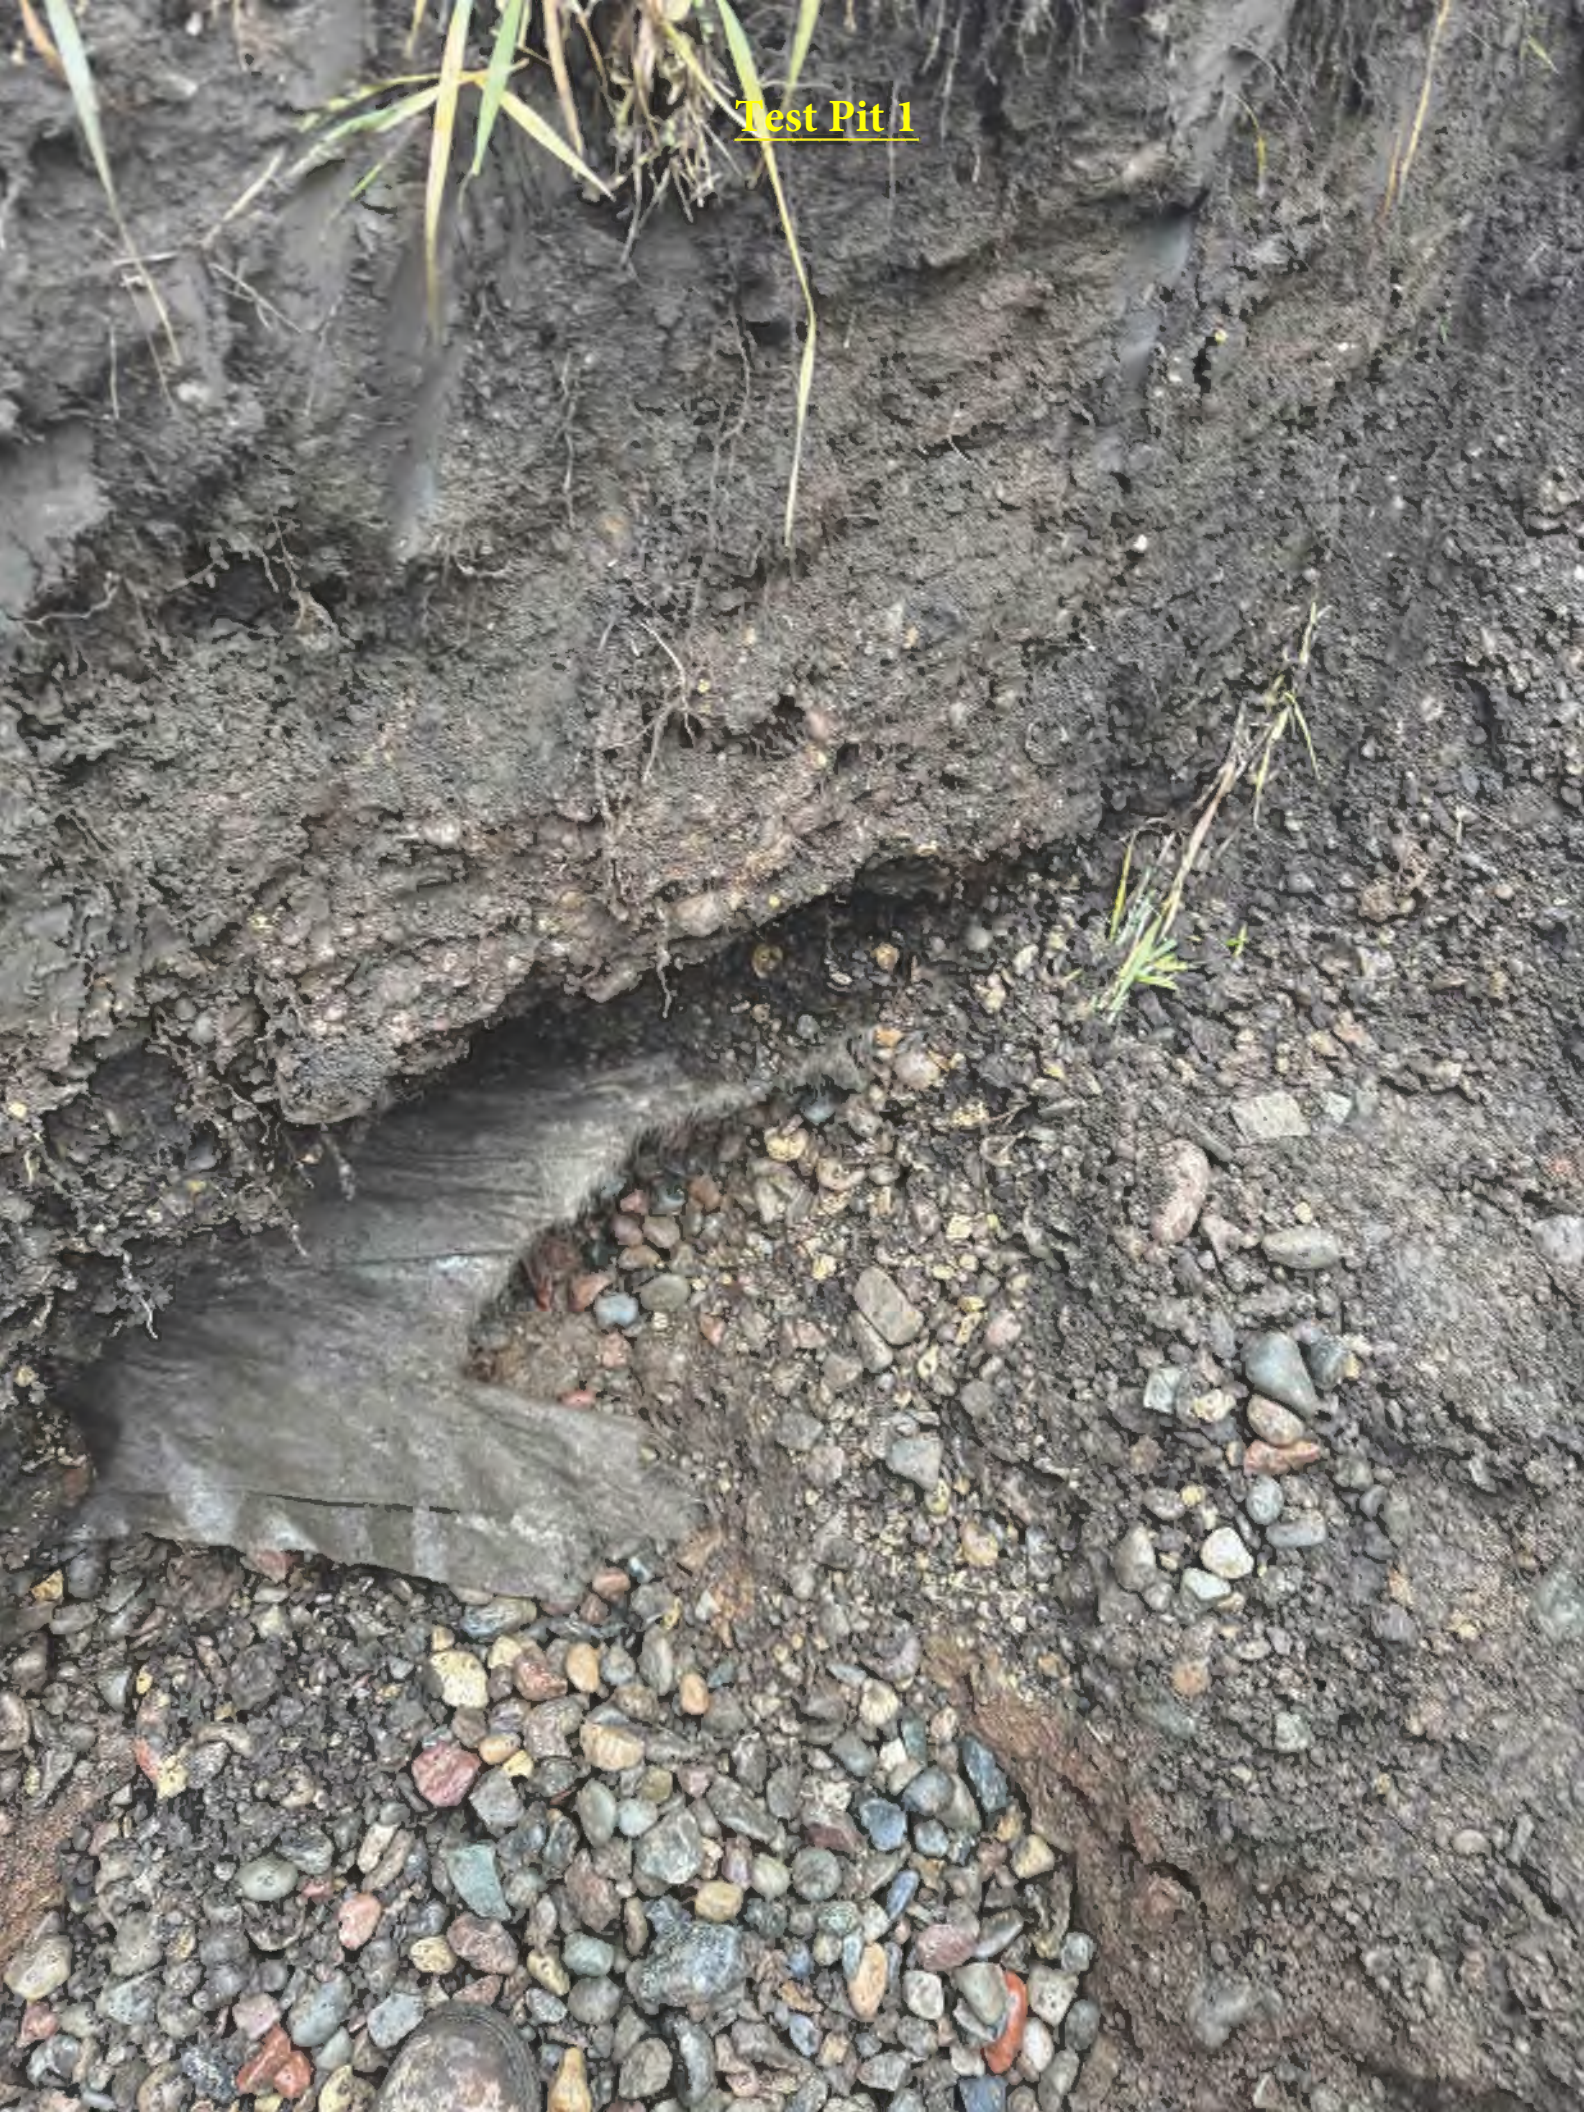
Test Pit 1

MSS inspected the soil conditions looking for signs of recent ponding or significant biomat build-up. Biomat refers to a black layer that is formed from Bacteria and microorganisms. Biomat treats the wastewater physically, chemically, and biologically before it reaches groundwater, and it typically forms where the filter rock meets the native soils. While the biomat is necessary for treatment, excessive biomat formation is a negative sign for many reasons as it can mean reduced soil permeability and cause ponding and ultimately failure of the system. Excessive biomat usually is a sign that the system is near the end of its design life and/or that the cells are not being properly operated. The first two excavations were performed on cells that are currently in operation. The last two were taken from the cells that were in operation in the last cycle. The general results of the excavations are shown in Table 1, below.

Table 1 - Inspection of Soil Conditions		
Excavation	Cell	Findings
1	4a	no observable biomat or ponding
2	2	no observable biomat or ponding
3	13	minimal biomat and no ponding
4	15	no observable biomat or ponding

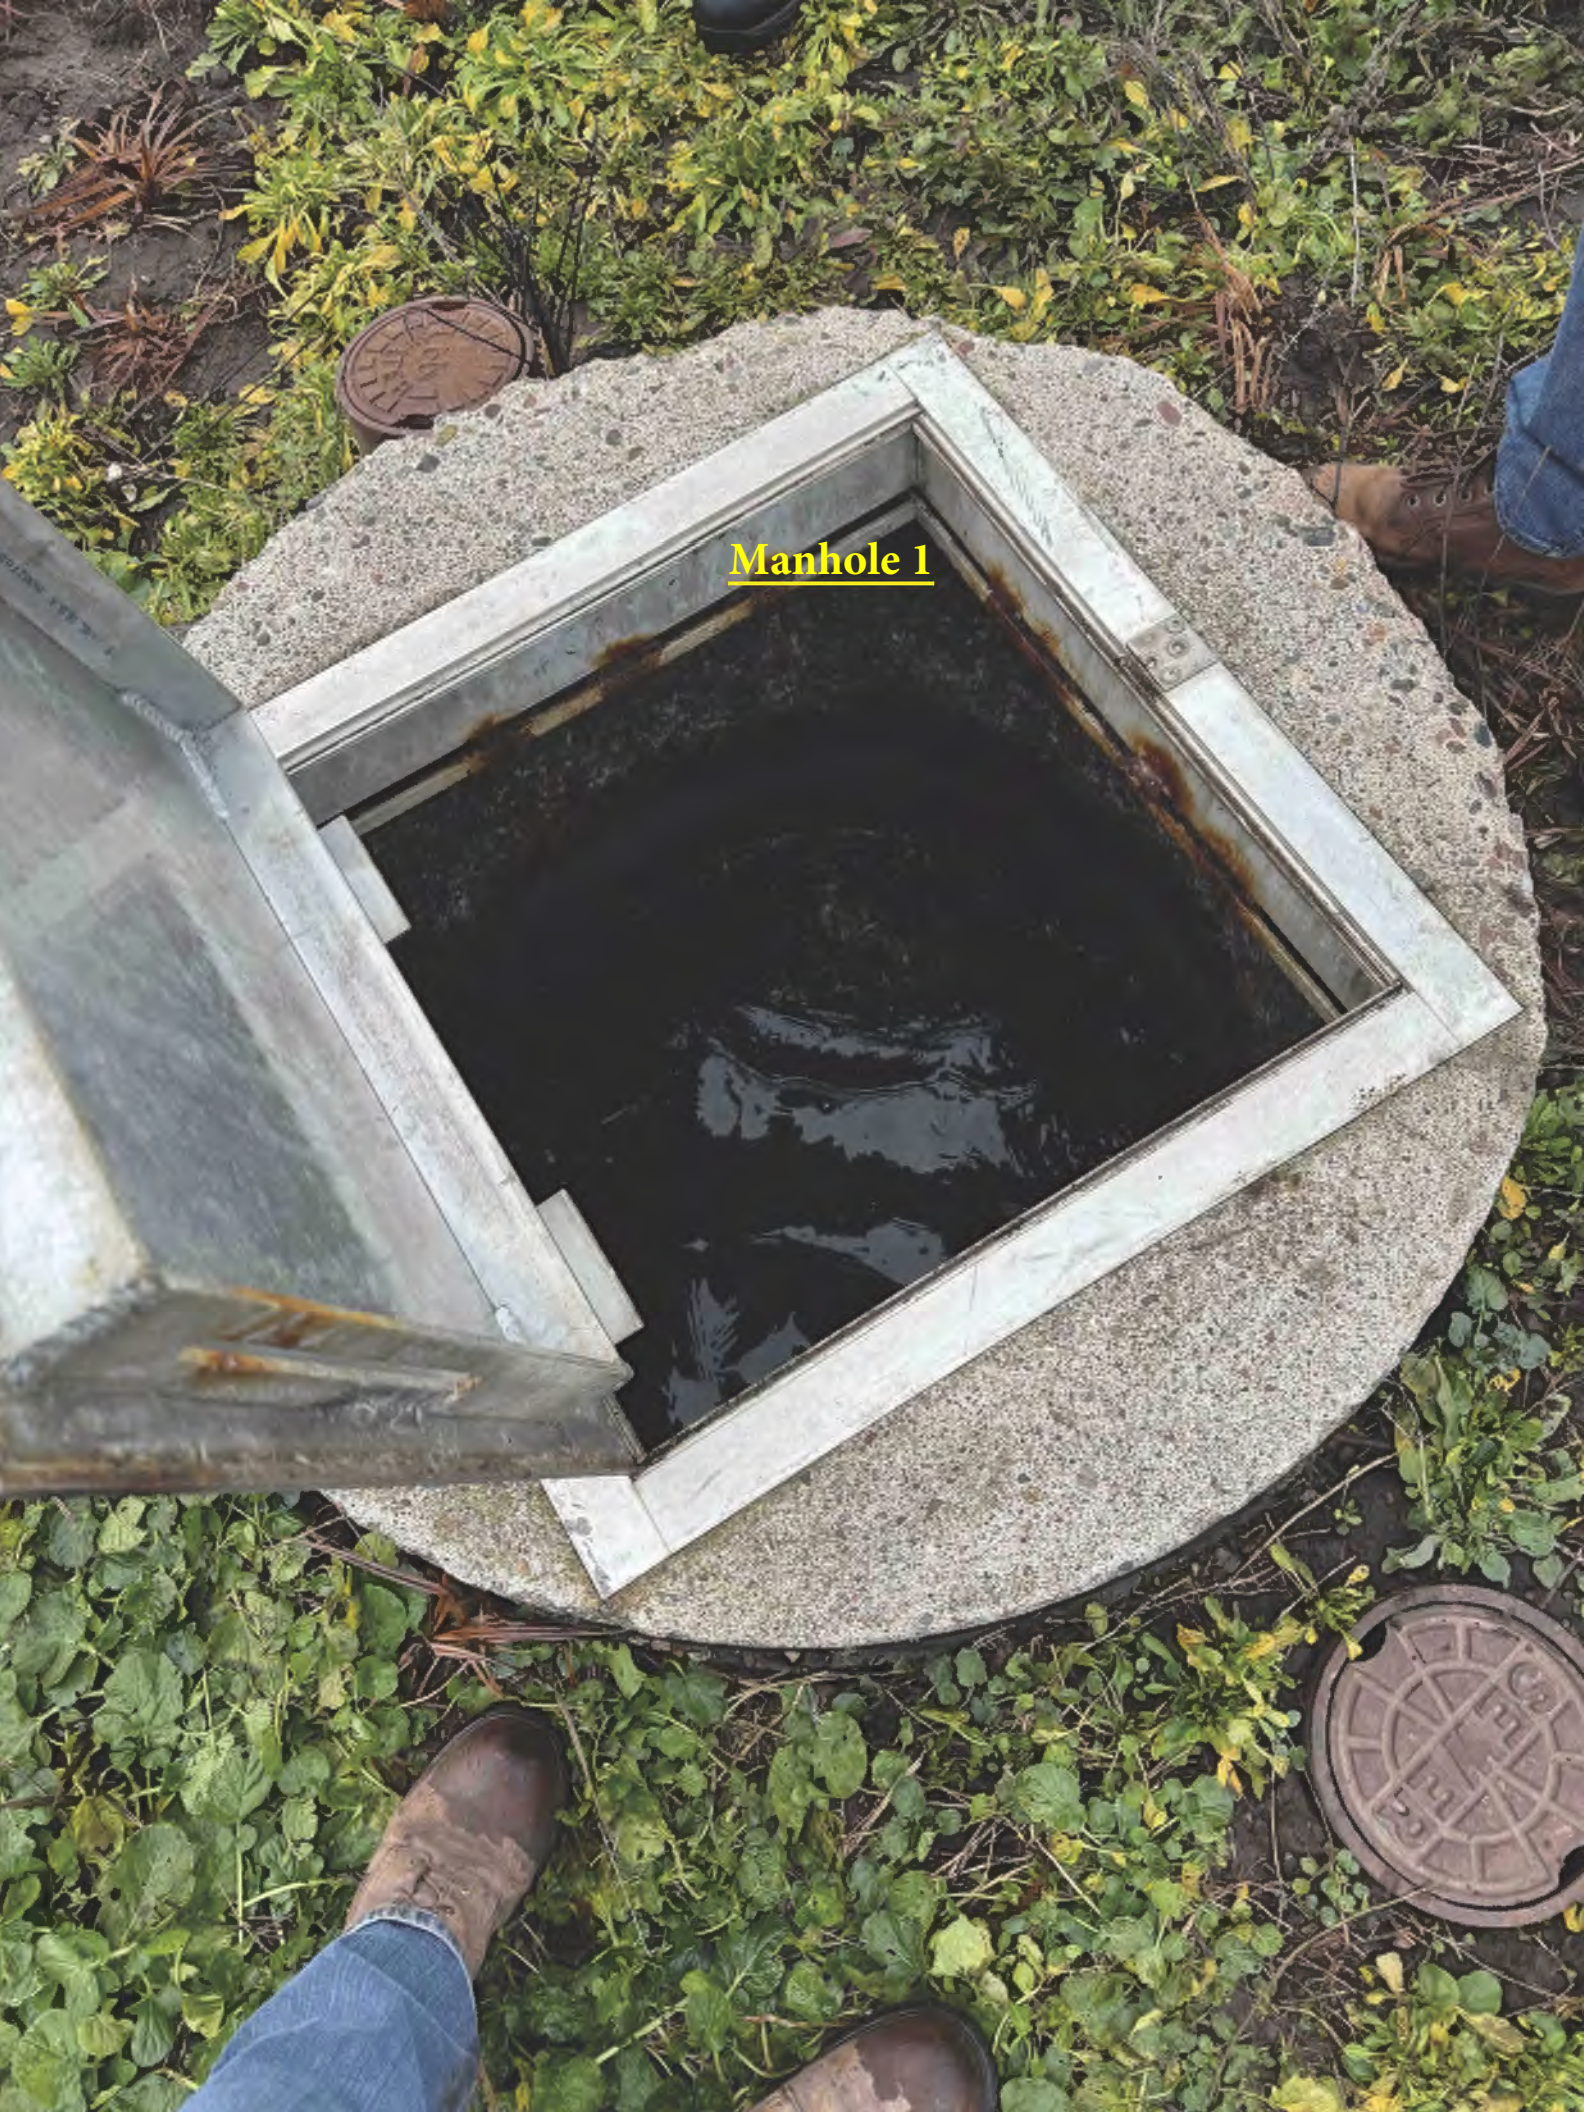
Manhole 1

The inspection of the control structure manholes found that many are in poor condition. The concrete in these structure, in particular the grout forming the bottom inverts, is deteriorating and exposing the aggregate. This likely has to do with the corrosive nature of the wastewater entering the treatment system. While much of the solids in the wastewater have been removed by septic tanks in the system, the wastewater must pass through one or more lift stations and a nearly mile-long forcemain before reaching the treatment system. Anaerobic conditions in these parts of the system promote the formation of hydrogen sulfide (H<sub>2</sub>S), which in turn can cause the formation of sulfuric acid once the wastewater reaches open air again (such as in the splitter structures). The third attachment to this memo

There are a few options that could be considered in dealing with these manholes. One would be replacement in kind of the existing structures. Most of these manholes have lasted 40 years or more and replacing in kind would in theory provide at least this same lifespan again. Alternately, additional steps could be taken to prolong and protect the life of the new structures, including coating the structures or using a specialized material for them, such as fiberglass or polymer concrete. Table 2 includes estimated costs per structure for these options, as well as a total cost if all 10 structures were to be addressed at once.
